Manhole Inspection Summary

Manhole # S13G1_016MH

Insp Date: **5/20/09 11:17 PM**

Location Address: **3212 W Patapsco Ave** Cross Street: **Washington Blvd**

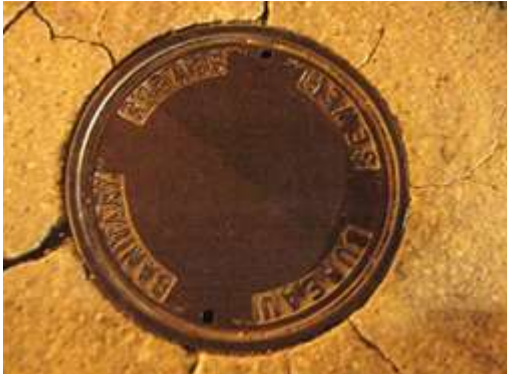
Miscellaneous

mh cover

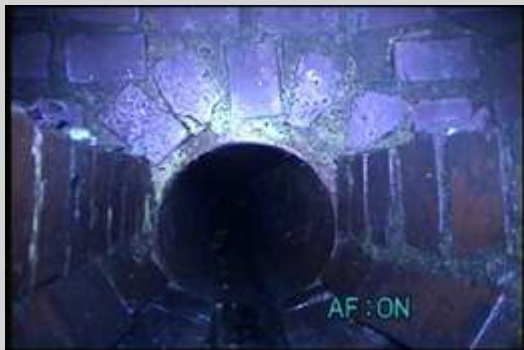
12 O'Clock Outflow

8 in. Circular Gravity Sewer
Pipe Out @ 12 O'Clock

Pipe Height: **8.4** (in.) Rod and Bar (Angled)
Pipe Material: **Clay** ☐ Pipe Lined
Invert Depth: **10.64** (ft.) Flow Characteristics: **Fast**
Deposits: ☒ None ☐ Mud ☐ Sludge ☐ Debris ☐ Grease
Silt Depth: **0** (in.) Deposits Extent:
Infiltration: **None** Pipe Seal Cond: **Sound**

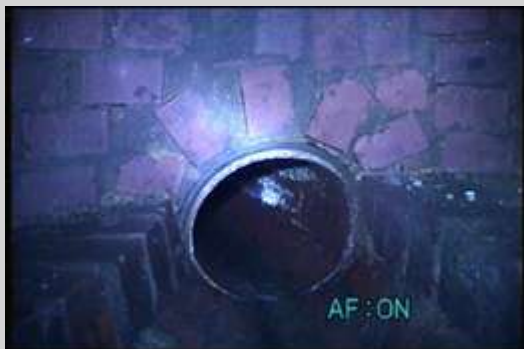
3 O'Clock Inflow

8 in. Circular Gravity Sewer
Pipe In @ 3 O'Clock

Pipe Height: **8.4** (in.) Rod and Bar (Angled)
Pipe Material: **Clay** ☐ Pipe Lined
Invert Depth: **10.24** (ft.) Flow Characteristics: **Fast**
Deposits: ☒ None ☐ Mud ☐ Sludge ☐ Debris ☐ Grease
Silt Depth: **0** (in.) Deposits Extent:
Infiltration: **None** Pipe Seal Cond: **Sound**

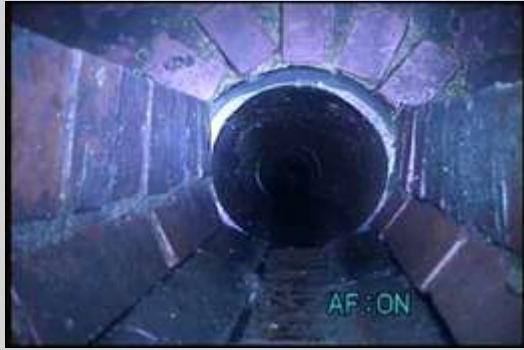
6 O'Clock Inflow

8 in. Circular Gravity Sewer
Pipe In @ 6 O'Clock

Pipe Height: **8.4** (in.) Rod and Bar (Angled)

Infiltration: **None** Pipe Seal Cond: **Sound**
